di Savoi Massimo

Milk powder reconstitution

From: Plants in Algeria

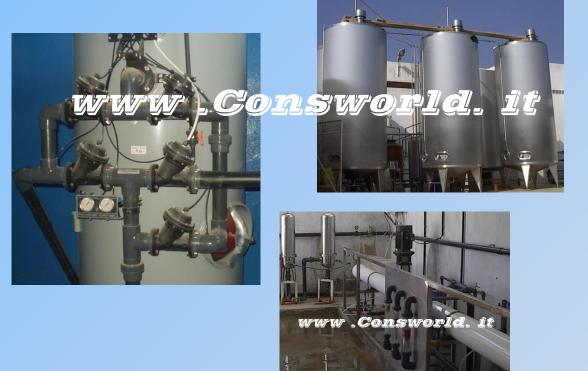
Step 1

All processing steps : WATER TREATMENT

Water storage and treatment. These operations are extremely important for the quality of milk produced. Key objectives are elimination of foreign objects, treatment of water hardness and elimination of any bacterial charge

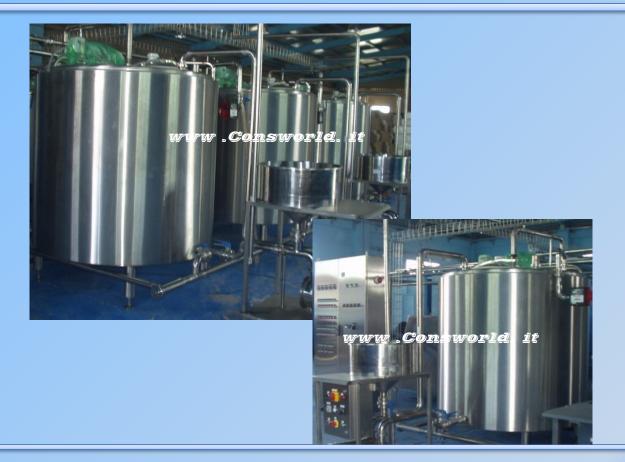
Step 2

All processing steps : MILK RECONSTITUTION

Milk powder is supplied to blender and melted into pre-heated water. Turbo stirrer ensures a perfect melting

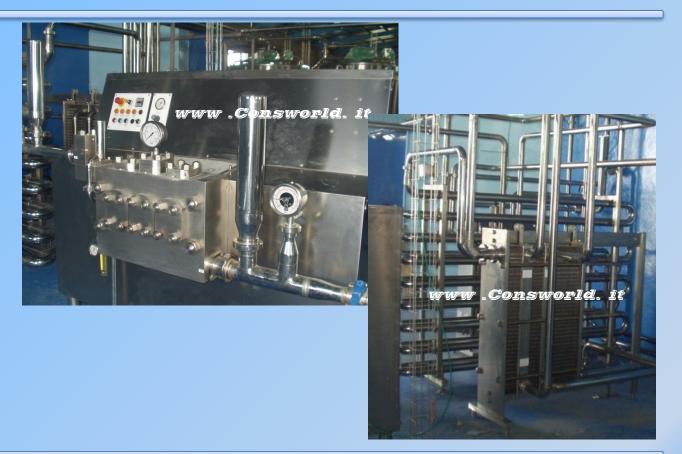
Step 3

All processing steps : HOMOGENIZATION AND PASTEURIZATION

Milk is now reconstituted and without clumps. It is first homogenized and then pasteurized

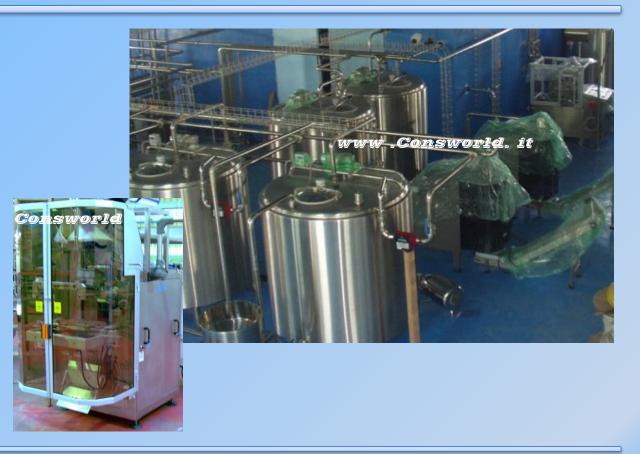
Step 4

All processing steps : STORAGE AND PACKAGING

Pasteurized milk cooled down to 4°C is now supplied to a buffer tank and then immediately after packaged into bags or bottles
